Jim Oliver
Sampson Creek CDD
475 West Town Place, Suite 114
St. Augustine, FL 32092

**Re: December 18, 2018 - Roadway Maintenance Report
MDG Project No.: 16080.02**

In support of this task, this Roadway Maintenance Report summarizes the items observed during the December 18th, 2018 field investigation and provides recommendations for the CDD to consider.

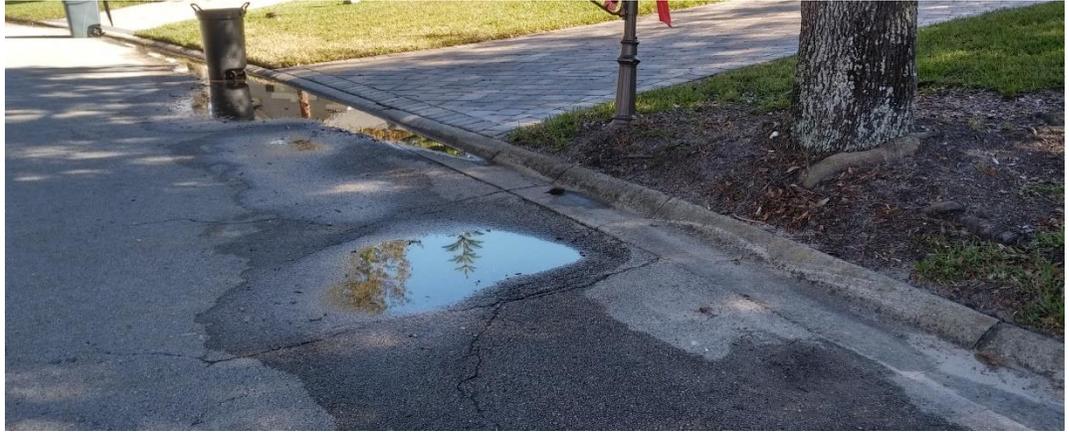
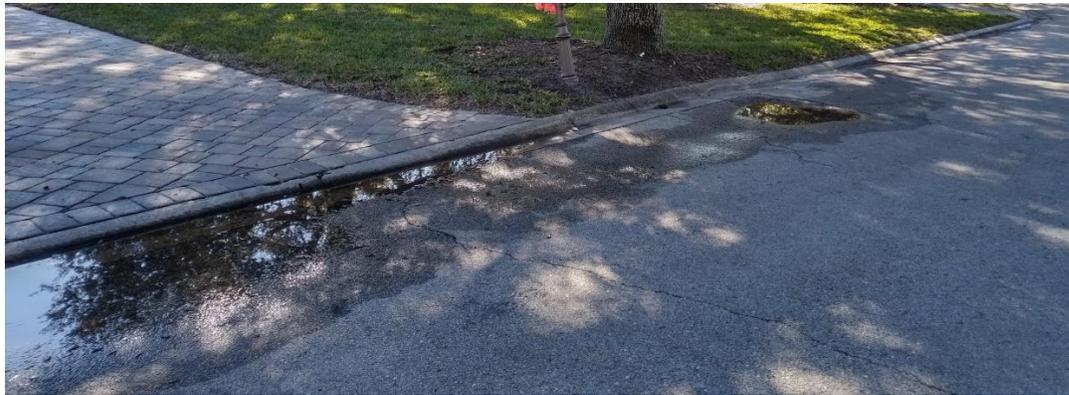
a. **Street Tree Category 1,2,3:**

1. The eastern curb line of Brookhaven Drive has apparent ponding and drainage issues, due to tree roots affecting the curb and pavement.
2. Stormwater is unable to flow southward to the inlet, providing for prolonged standing water.
3. Estimated to affect approximately 150 to 200 LF of the east side of the roadway.

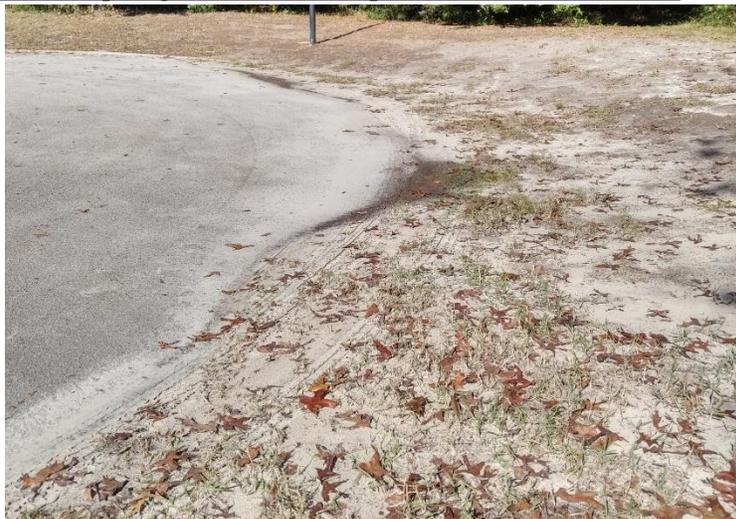
b. **Curb line cleanup; vegetation removal; potential curb installation:**

1. The terminal cul-de-sac has a build up of sediment and vegetation along the eastern and northern sides. It is possible that curb wasn't installed at this location due to potential future extension.

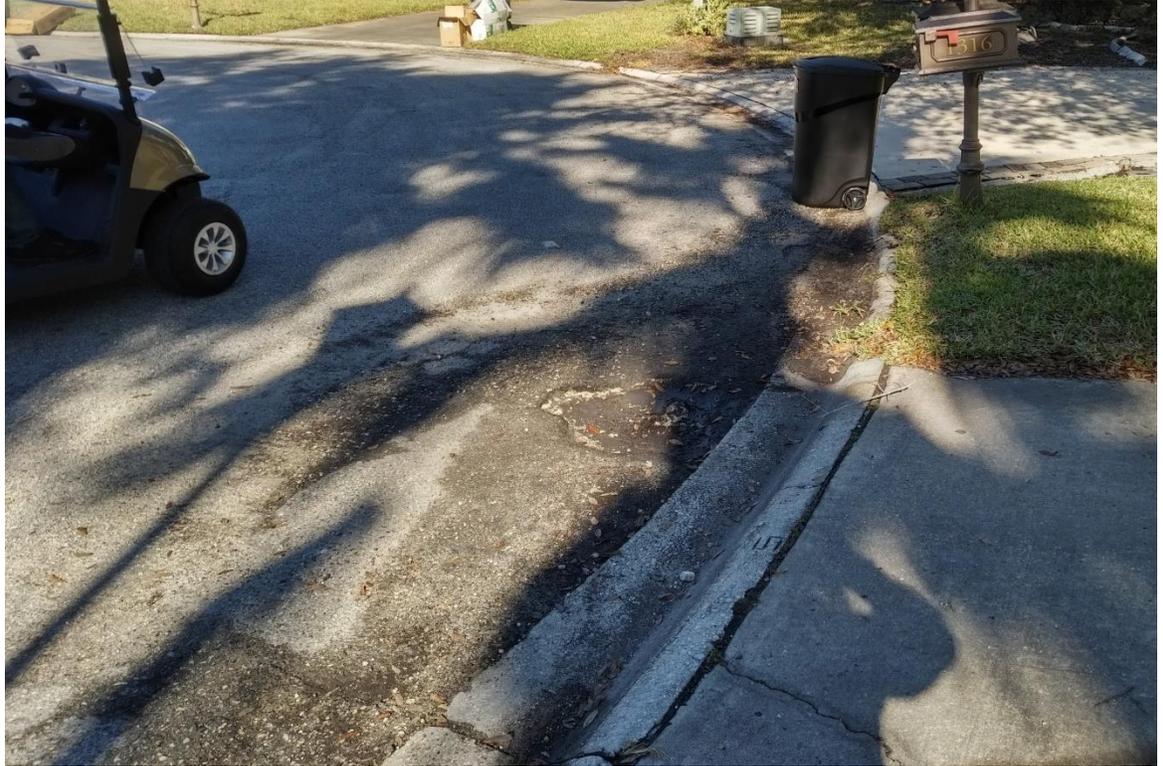
b. Cul-de-Sac Grading & Pavement Concern:

1. Pavement Damage at curb line due to poor drainage and curb design.
2. Recommend special patch to repair this location in front of 1316 Chelsey Circle.

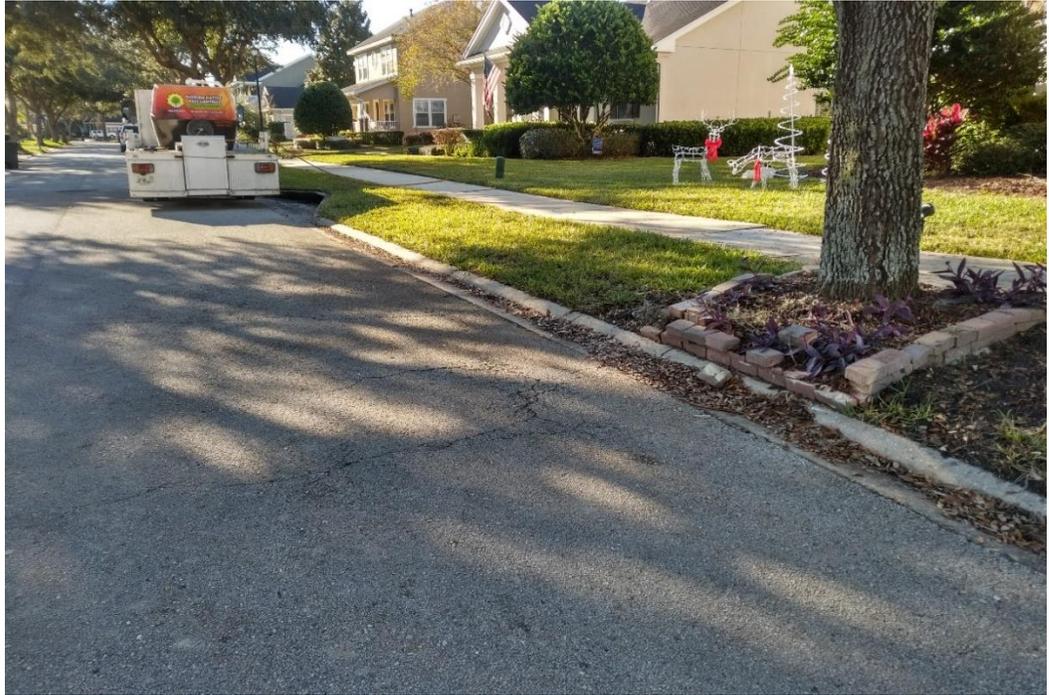
a. Street Tree Category 2:

1. Two (2x) trees were found to have substantial impacts to the roadway pavement along Drury Court.
 - a. STA 16+25 RT; 1521 Drury Ct.
 - b. STA 17+75 LT; 1532 Drury Ct
2. These two trees were not observed to be significantly affecting the roadway gutter.

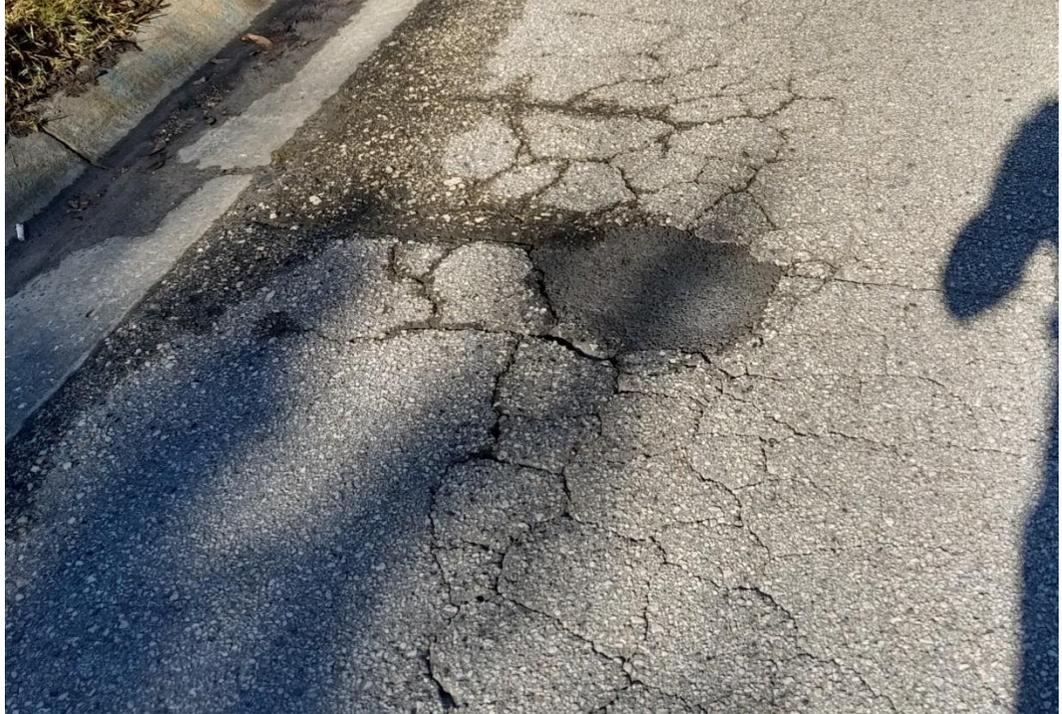
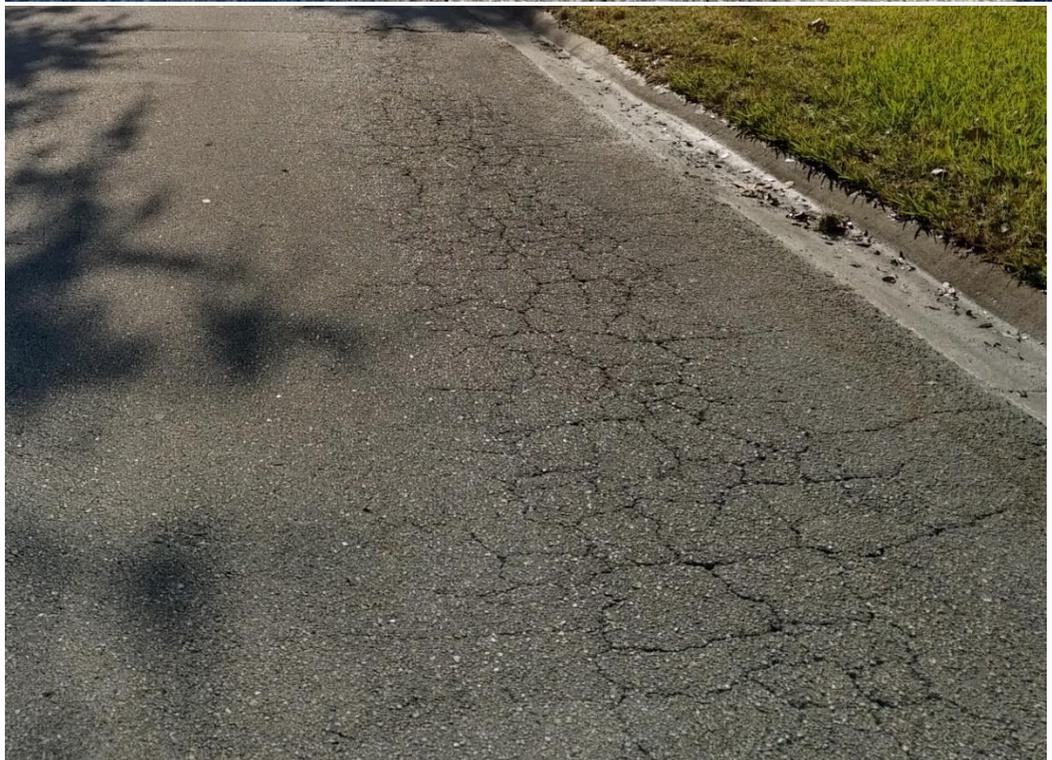
b. Typical Pavement Condition:

1. Noticeable cracking was observed @ STA 78+00 to 83+50

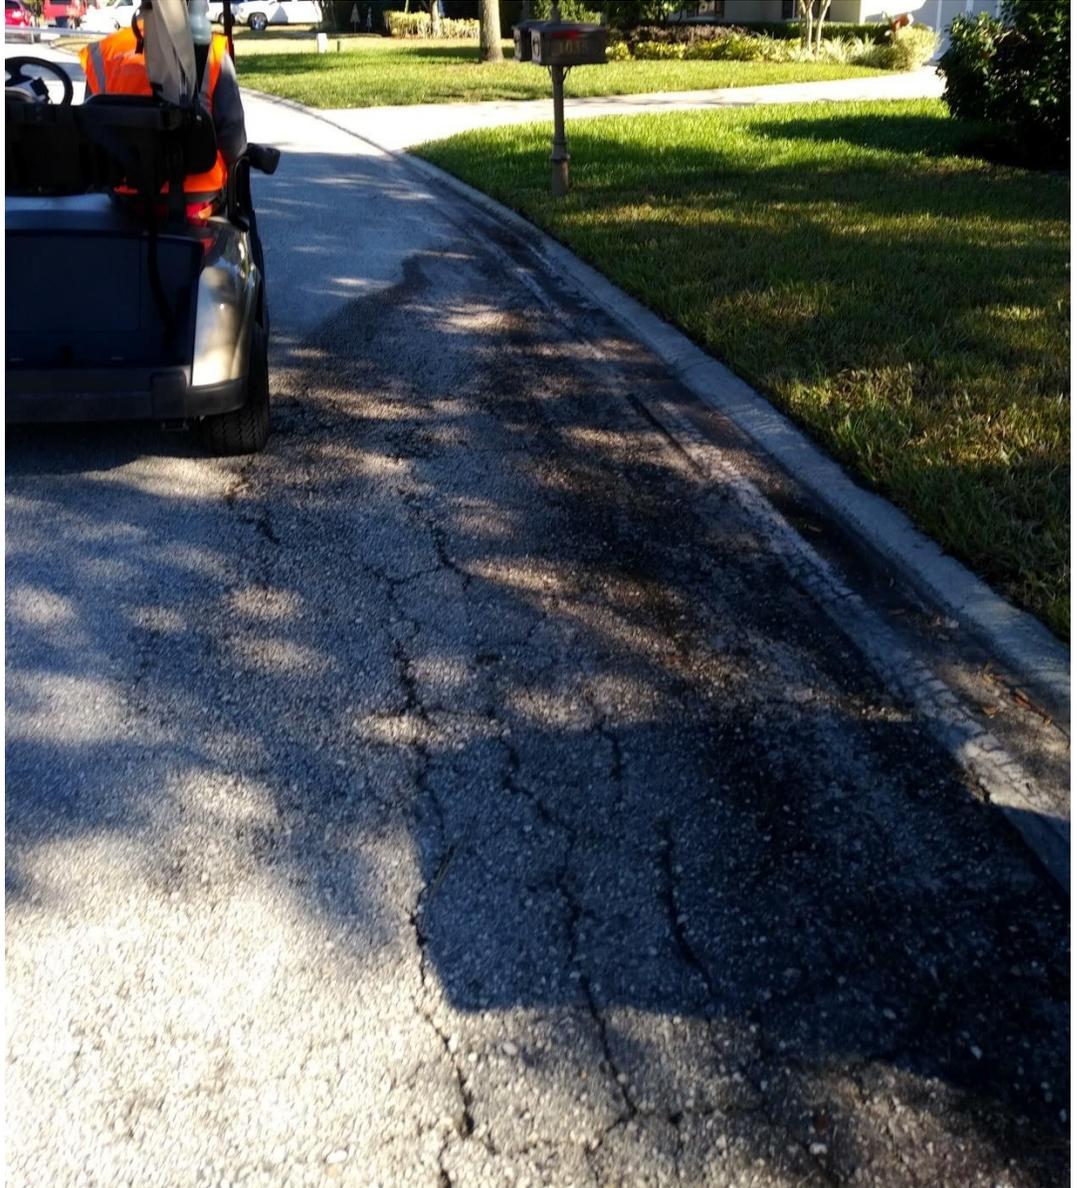
iii.

1. Poor drainage conditions and grading @ STA 47+00; 1035 Eagle Point Drive.
2. Site Specific Asphalt/Gutter Repair Recommended

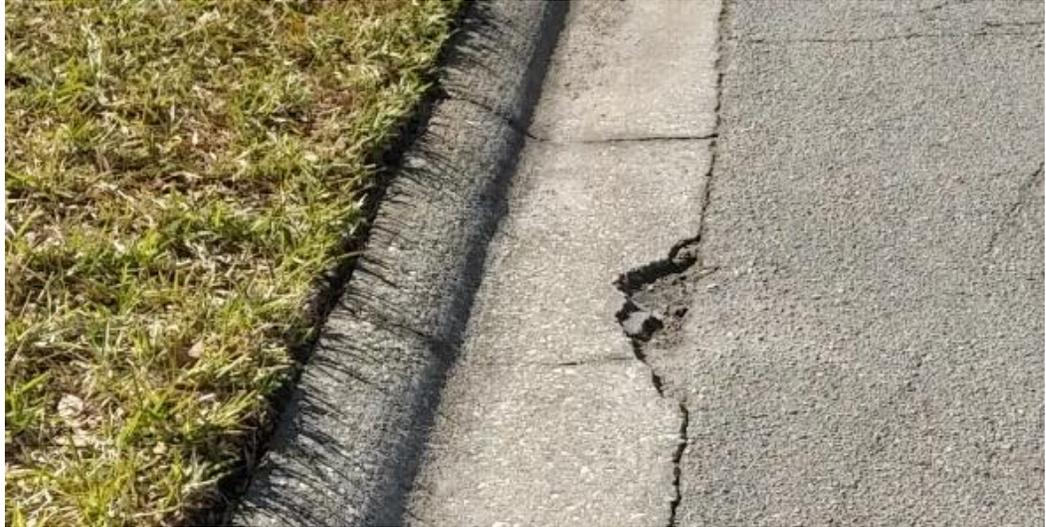
d. Curb and Gutter Repair:

- i.
 - 1. Chipped curb and gutter was observed in multiple locations.
 - 2. Recommend replacement @ STA 101+40, STA 103+00 totaling an approximate 15 feet.

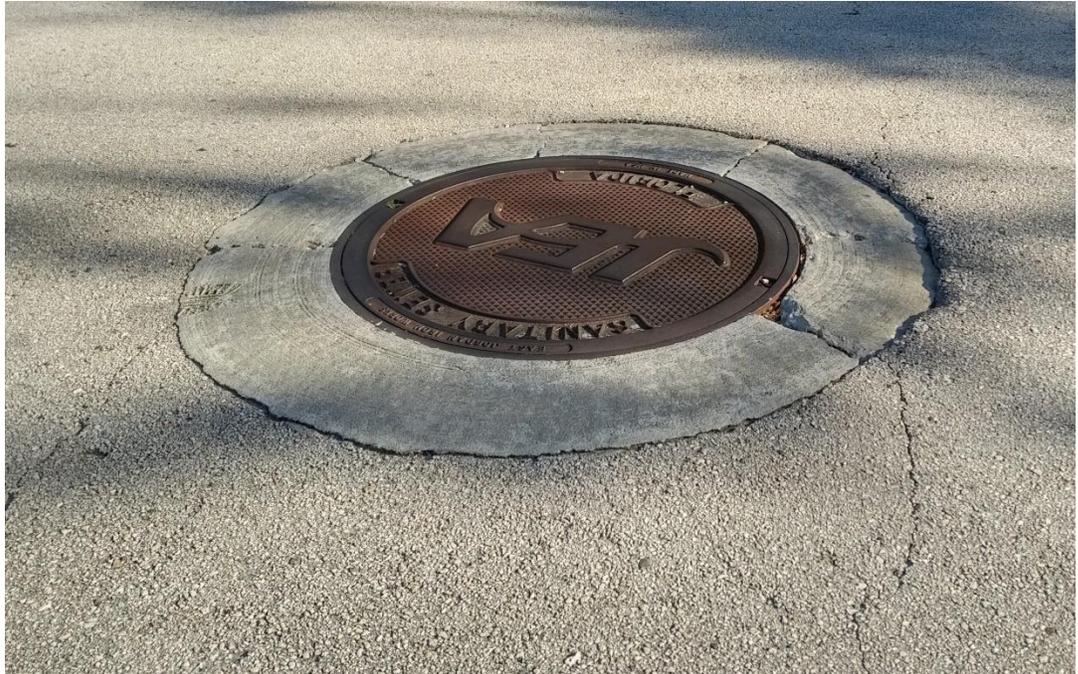
e. Manhole Considerations:

- i.
 - 1. STA 83+75

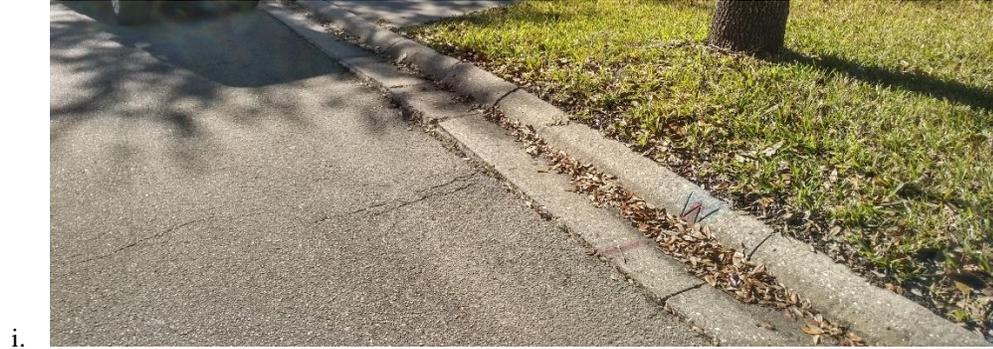
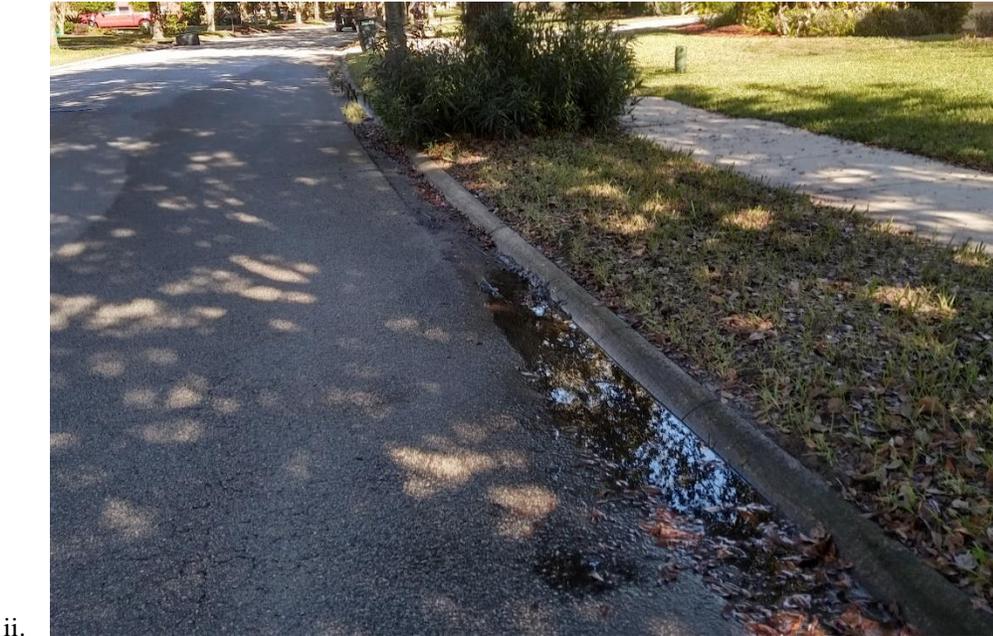
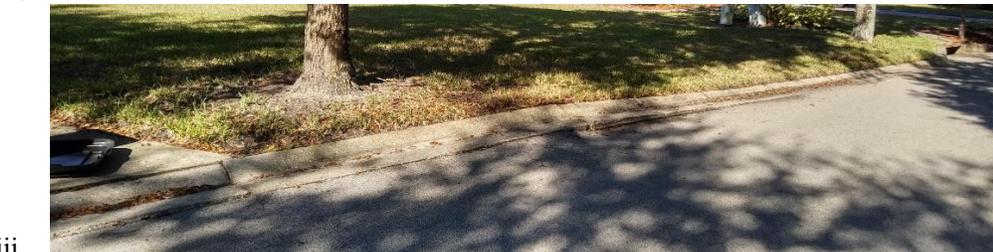
f. Street Tree Category 1,2,3:

1. Eagle Point Drive has approximately 1,500' of roadway particularly affected by street trees (STA 103+00 to STA 118+00). A site-specific approach will need to be taken to address the particular concerns of the CDD in this location.
2. The severity of each tree's impact varies, but significant impacts to the curb and gutter flow lines were observed as well as significant impacts to the roadway pavement.
 - a. Significant standing water was observed in multiple locations, on both sides of the roadway.

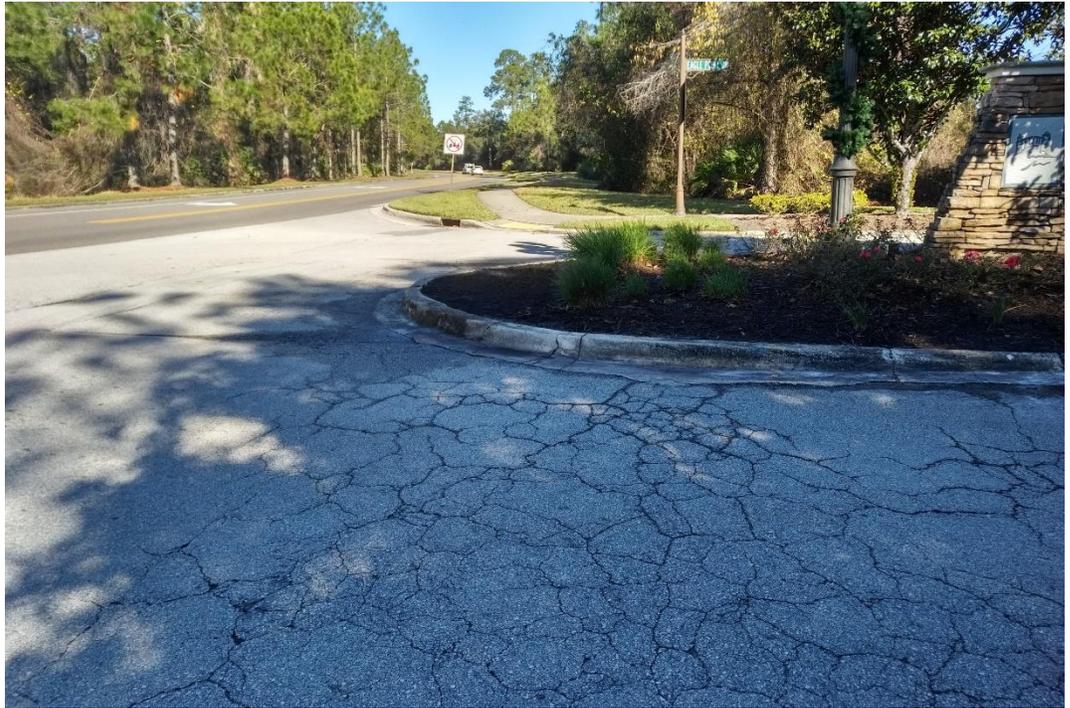
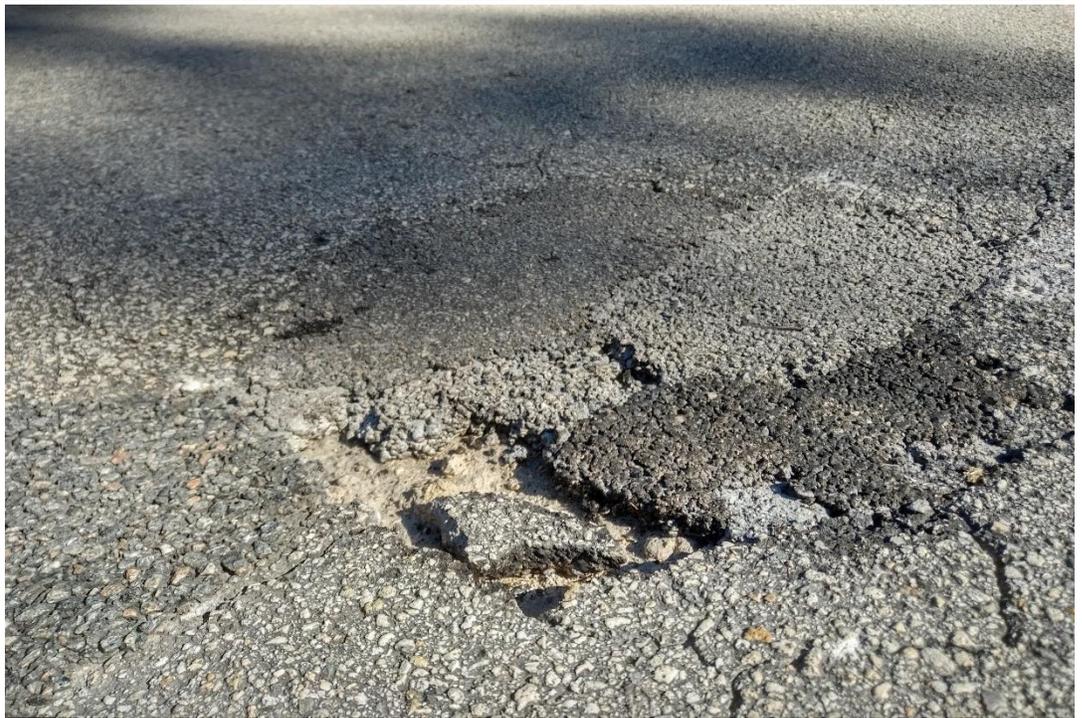
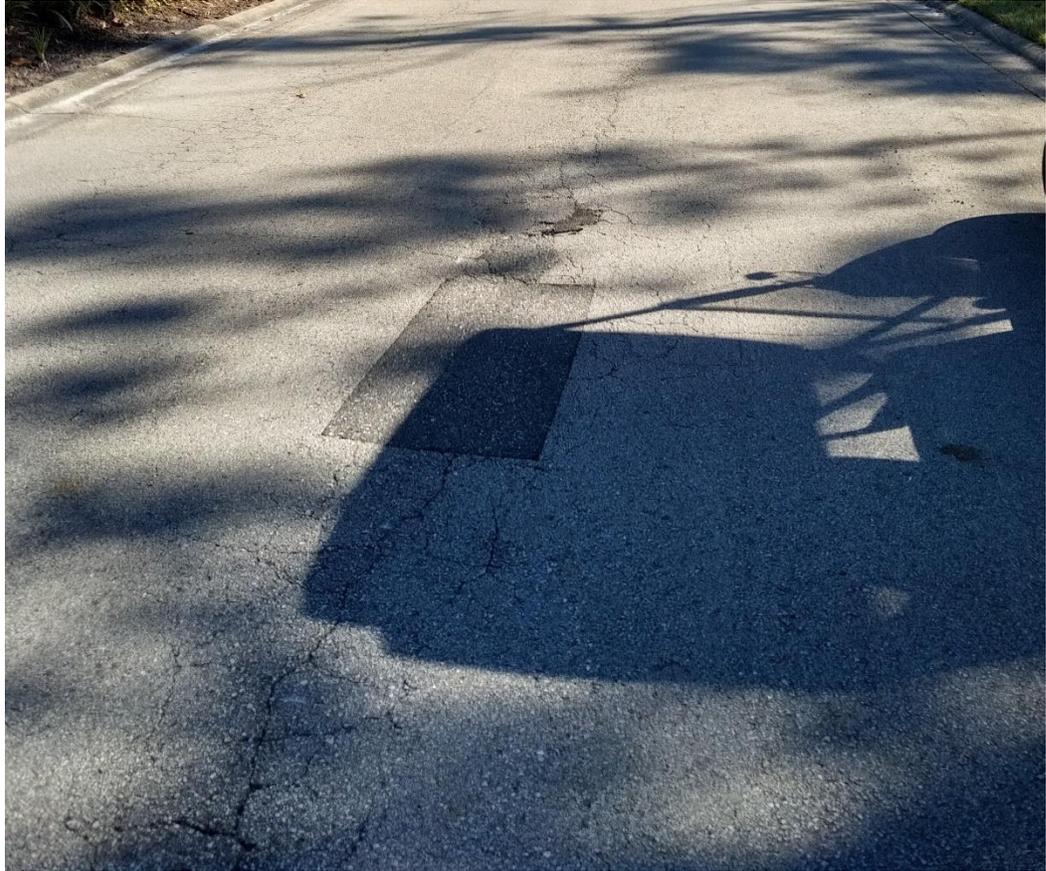
g. Leo Maguire Parkway Entrance:

1. Approximately 300' approaching the intersection, the pavement was observed to have significant cracking with low spots, thin pavement, chipping and holes.
2. Locations where chipping and holes have occurred, it was observed that the asphalt thickness is relatively thin.
3. Asphalt patches were observed, with failure apparently following the repairs.

As the longest roadway of the subdivision, Eagle Point Drive serves as a primary collector road for the residents and is exposed to increased traffic. Significant wear was noted through the travel lanes along many portions of the roadway. Considering the pavement concerns noted above, it is recommended to have pavement cores taken strategically in order to provide the best milling and resurfacing design.

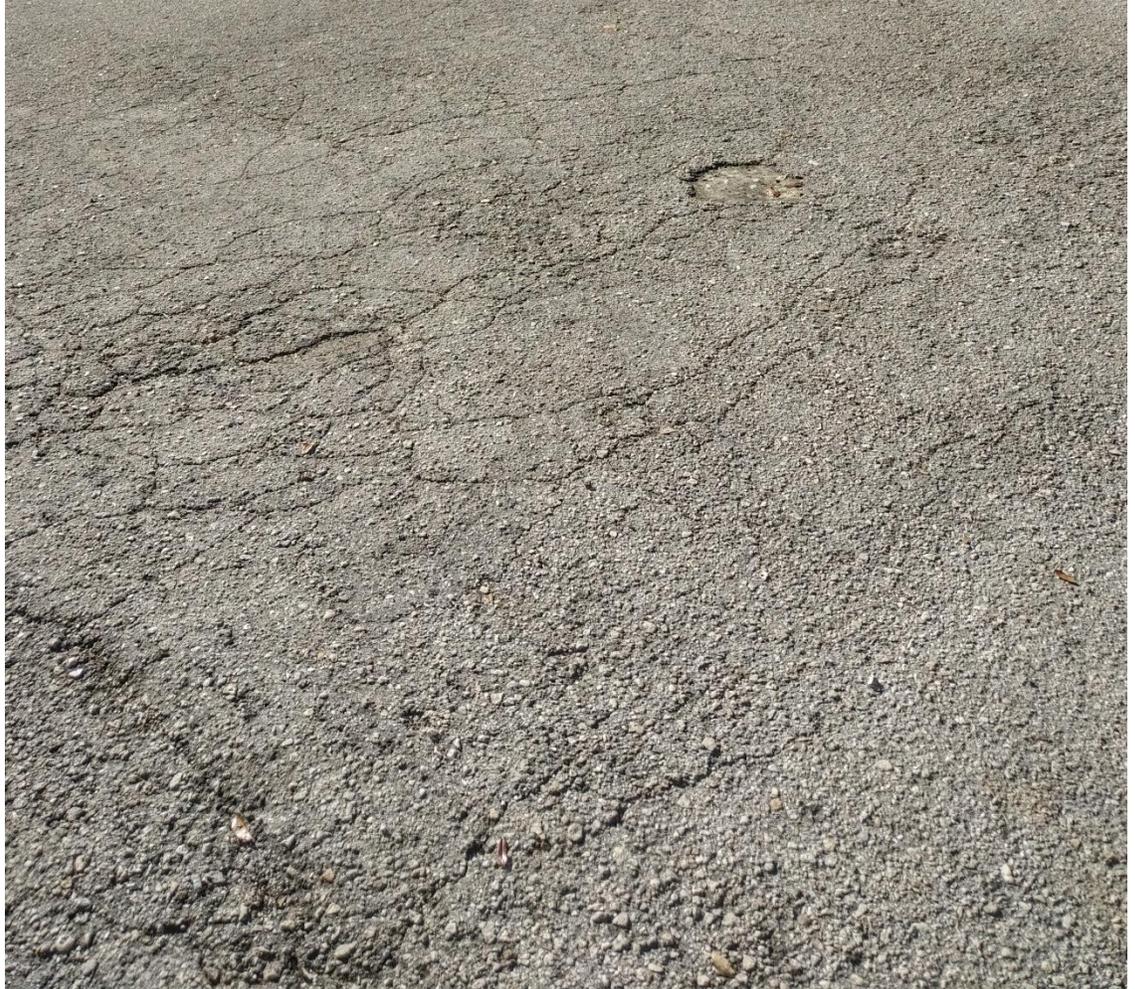
b. Thin Asphalt:

1. Cracking and Chipping was observed within the terminal cul-de-sac.

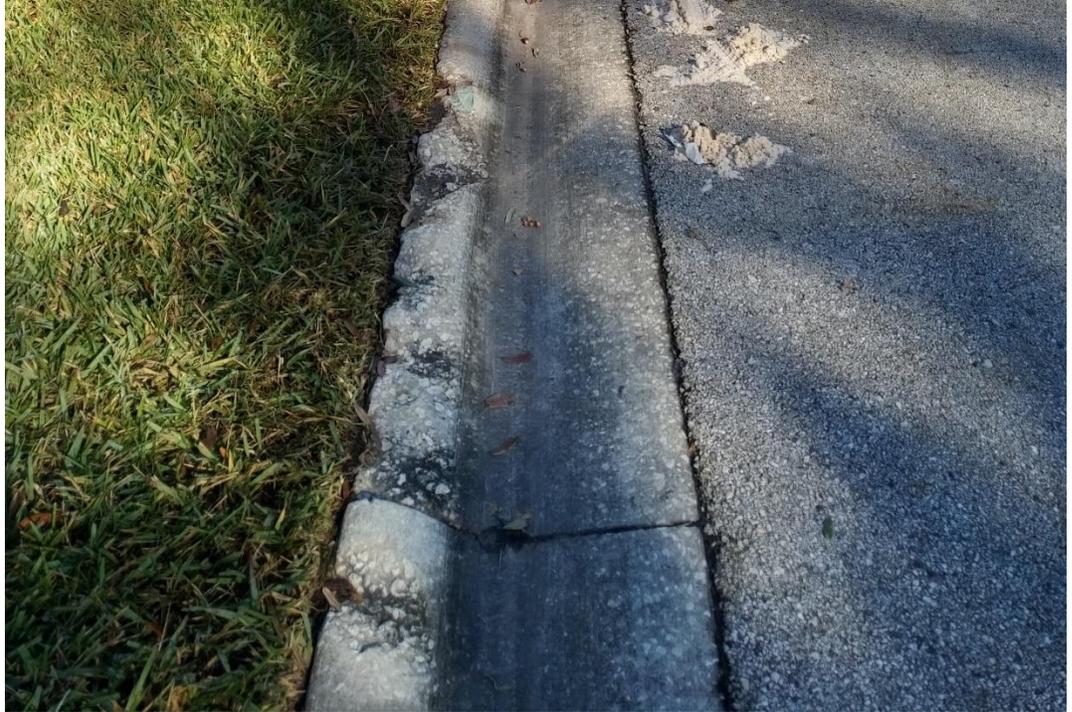
a. Curb & Gutter:

1. Damaged Curb was observed in two locations, totaling an approximate 15 feet.

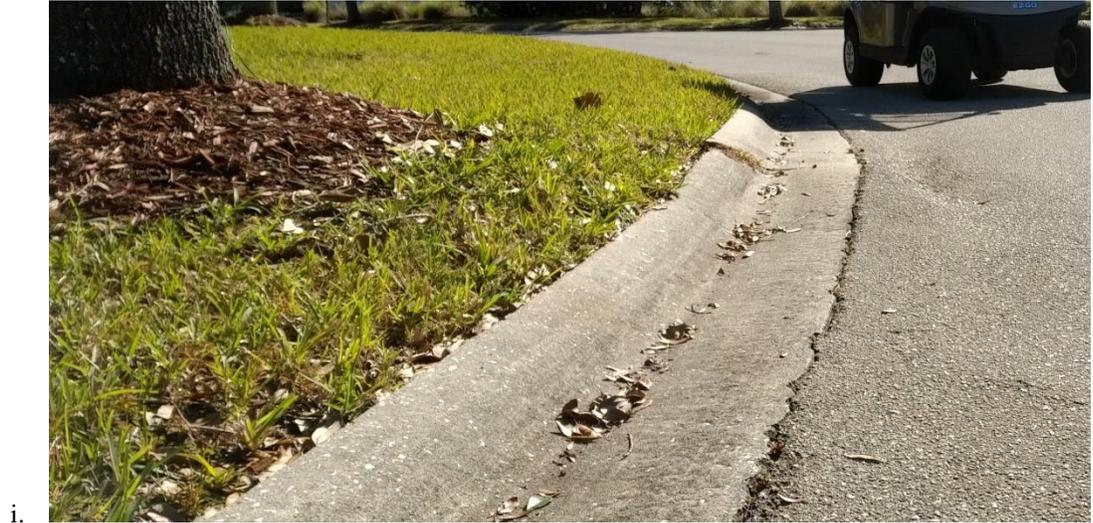
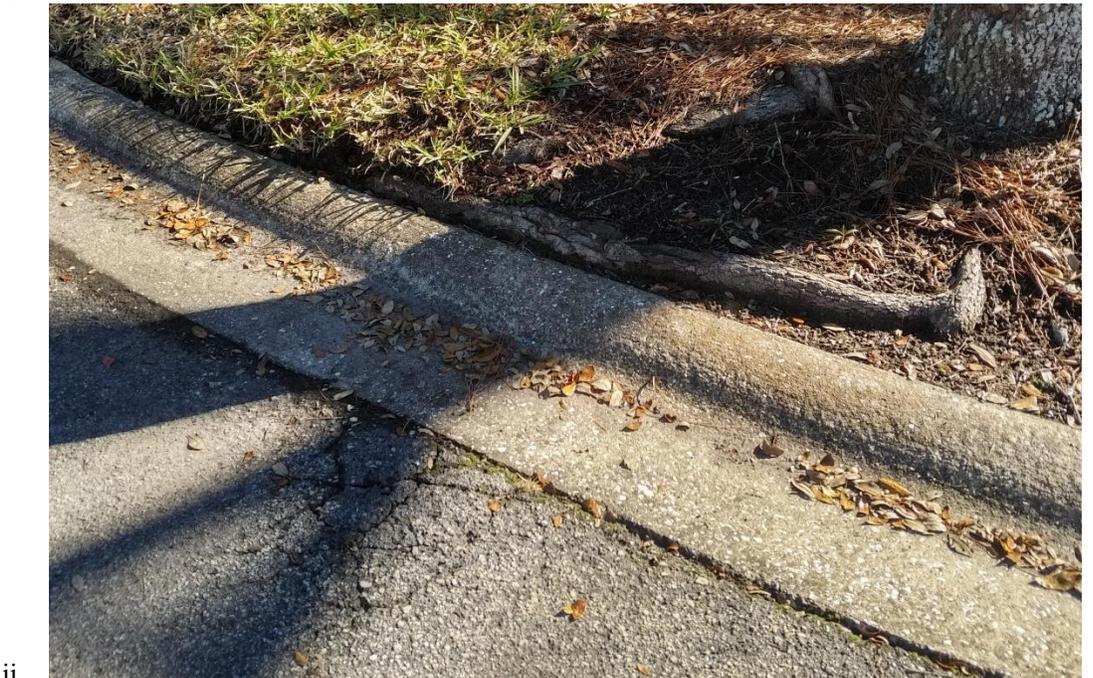
a. Street Tree Category 2:

1. This roadway was observed to have two (2x) trees which were observed to be significantly affecting the roadway pavement.
 - a. STA 14+00 LT, 15+00 RT,

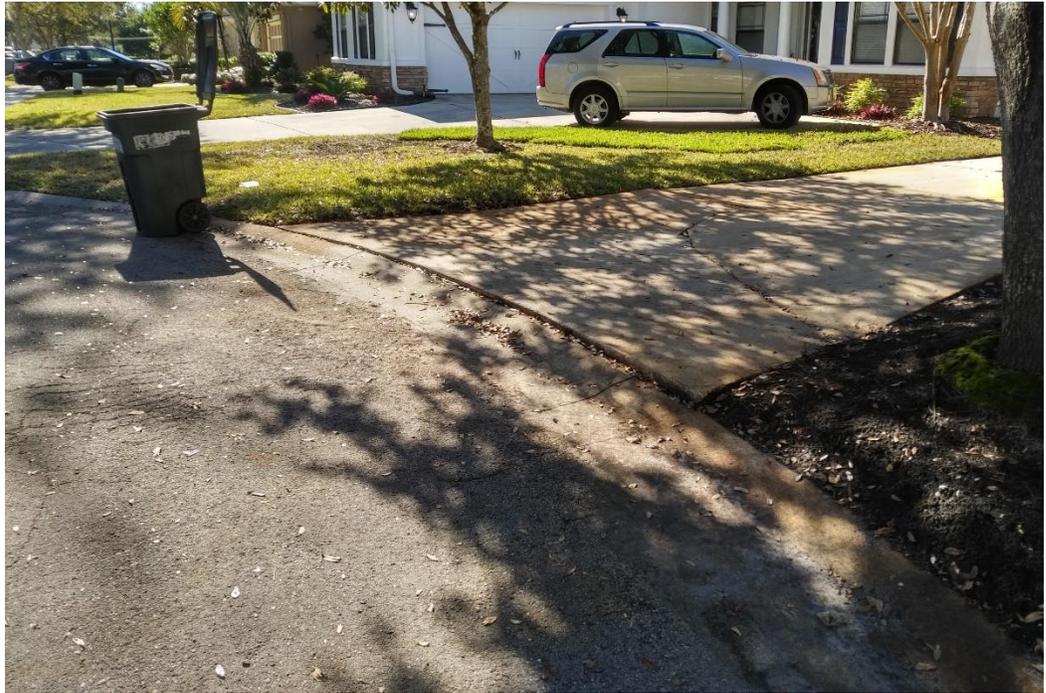
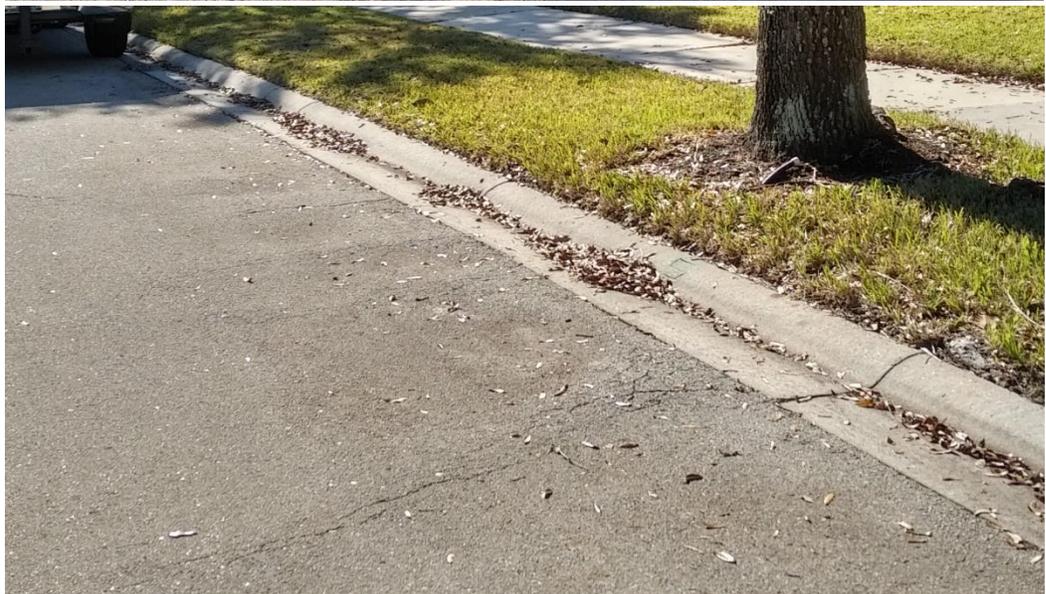
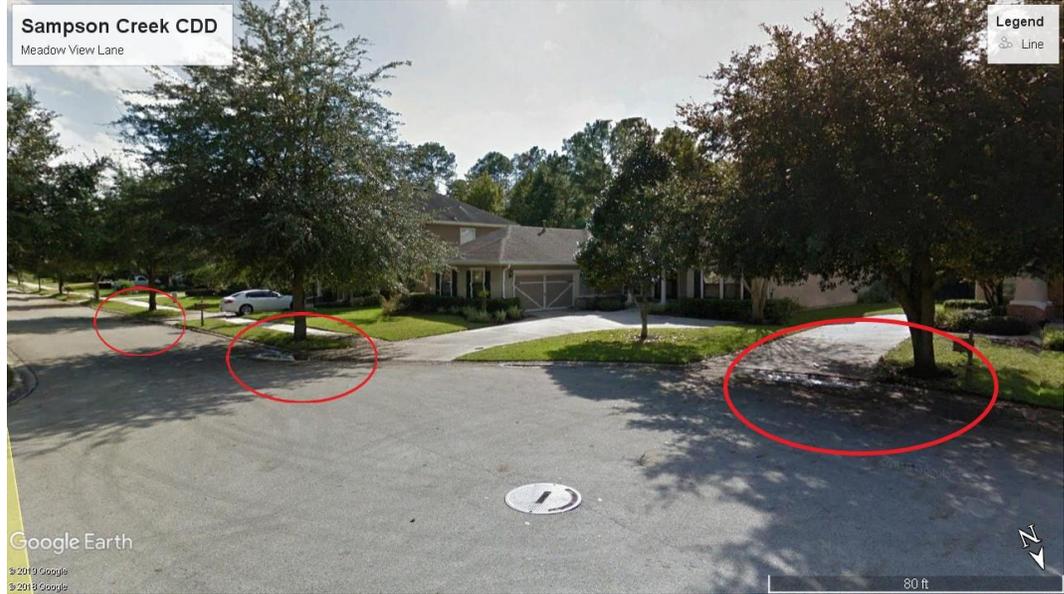
b. Street Tree Category 1,2,3:

1. A low spot observed within the terminal cul-de-sac is suspected to be a result of three consecutive street trees affecting the curb and gutter flow line. This results in depressional areas which allow for prolonged standing water.
2. The area affected is approximately 200' from (STA 23+00 LT to STA 24+99 LT)

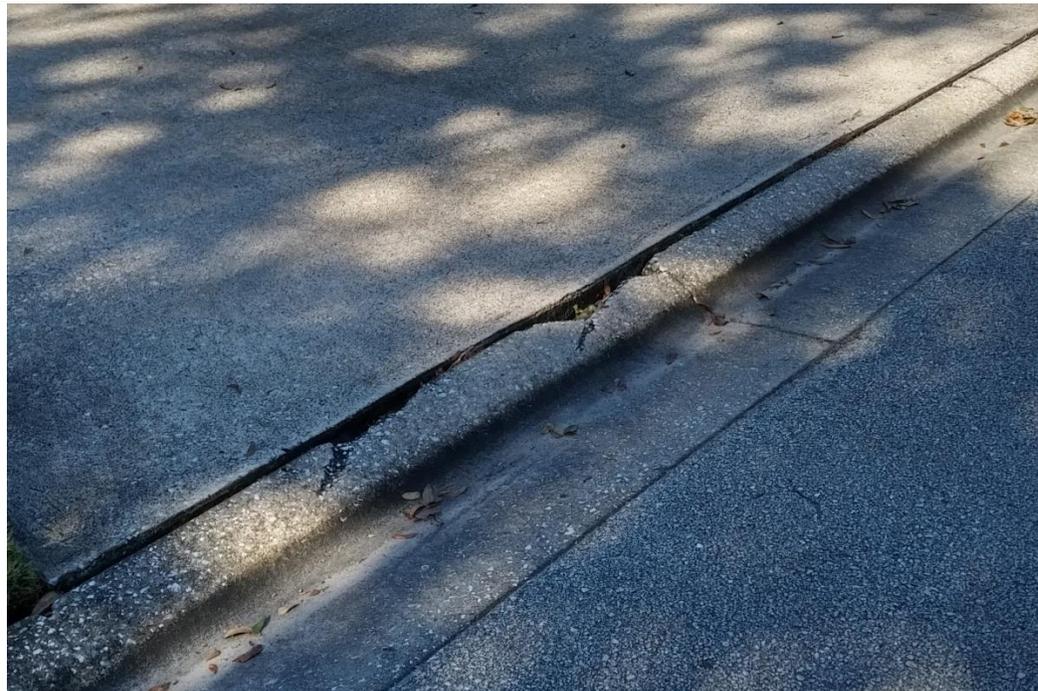
c. **Curb & Gutter:**

1. Curb and Gutter was observed to need replacement at 1053 Meadow View Lane. Estimated 5'-10'. (STA 19+500 LT)

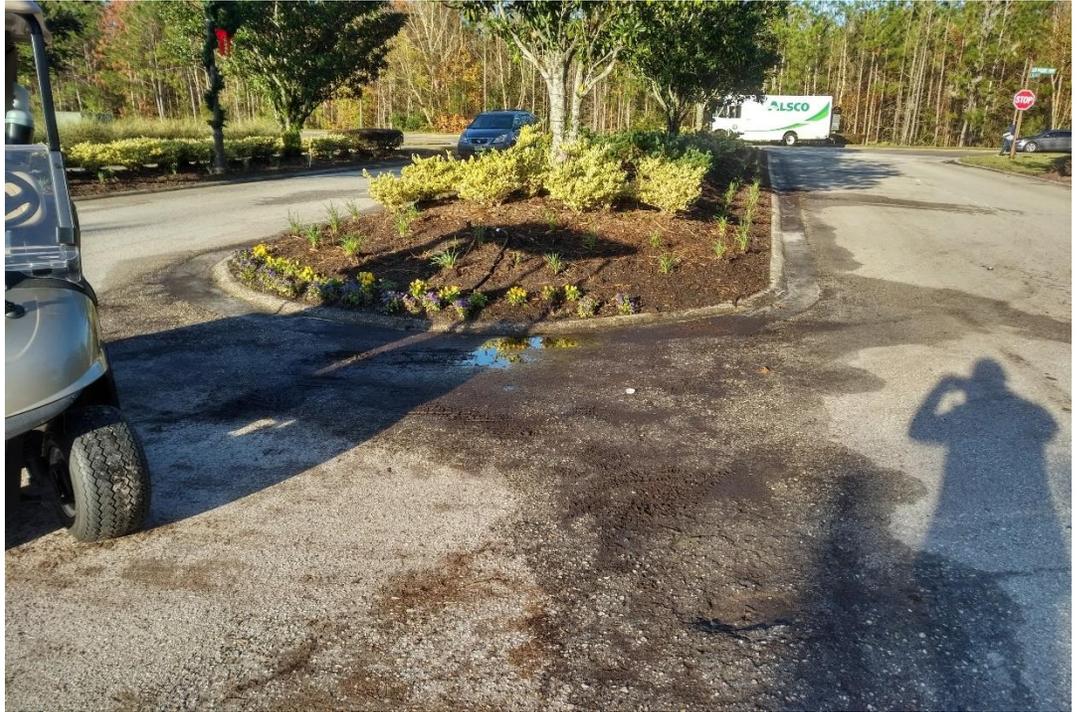
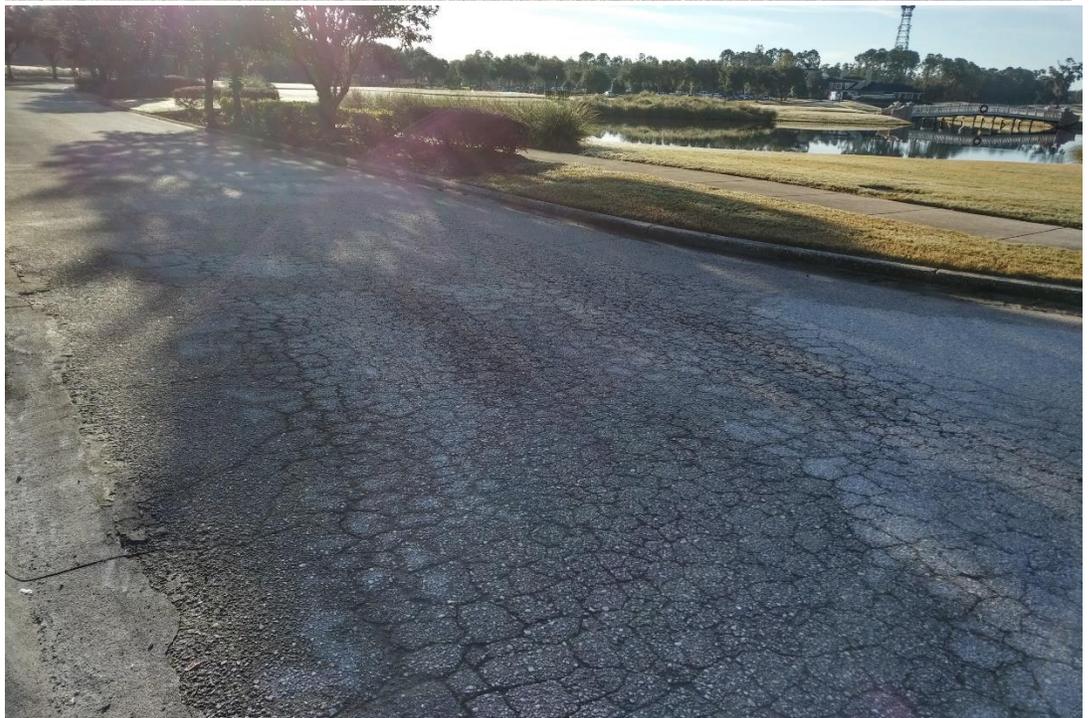
a. Leo Maguire Parkway Entrance:

1. Pavement was observed to have significant cracking with low spots, thin pavement, chipping and holes. (Approximately 500')
2. In locations where chipping and holes have occurred, it was observed that the asphalt thickness is relatively thin.

As the second longest roadway of the subdivision, St. Johns Golf Drive serves as a primary collector road for the residents and is exposed to increased traffic. Significant wear was noted through the travel lanes along many portions of the roadway. Considering the pavement concerns noted above, it is recommended to have pavement cores taken strategically in order to provide the best milling and resurfacing design.

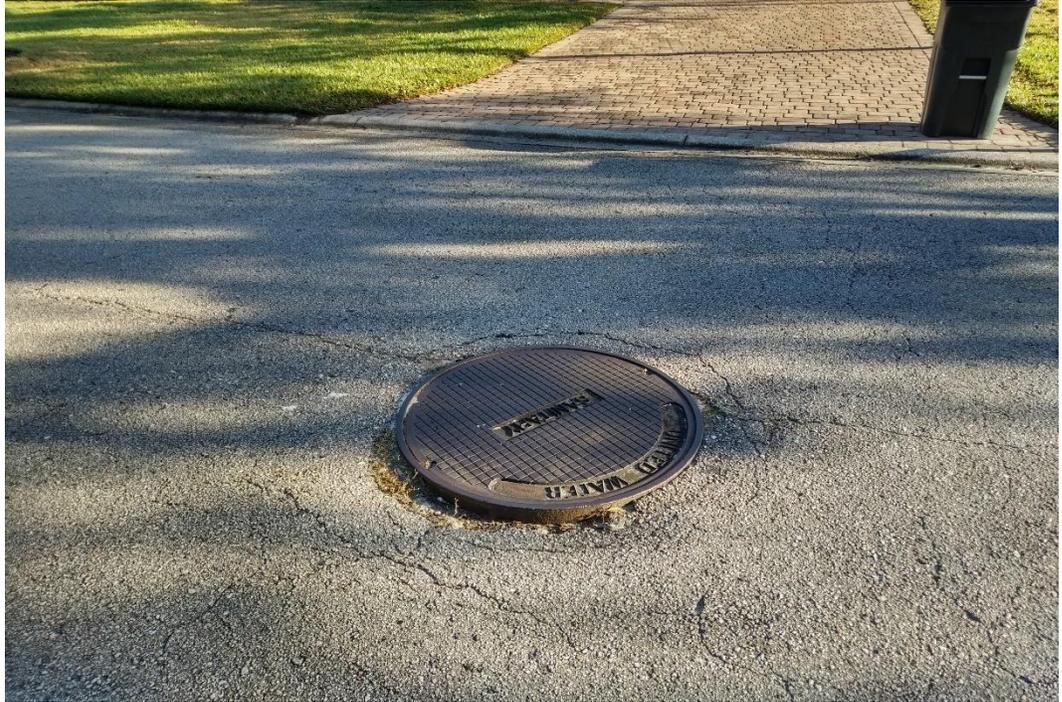
b. Sanitary Manholes:

1. Multiple Sanitary Manholes were observed to have settlement.
 - a. Possible causes for differential settlement:
 - i. Insufficient compaction.
 - ii. Leaking sanitary laterals or sanitary mains.

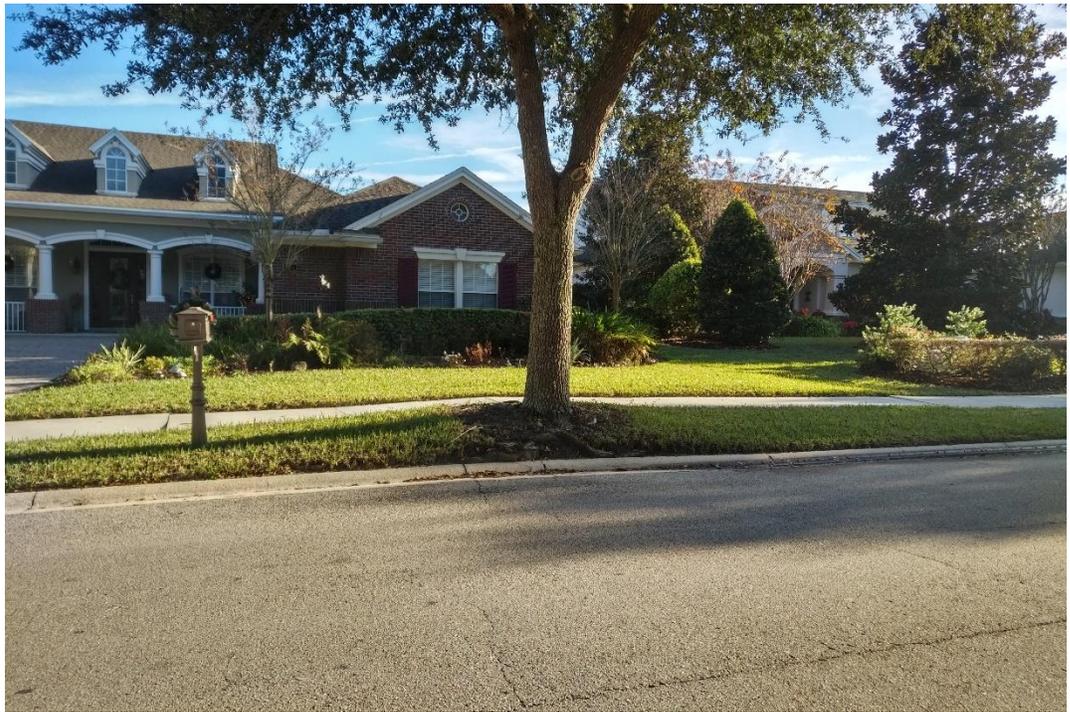
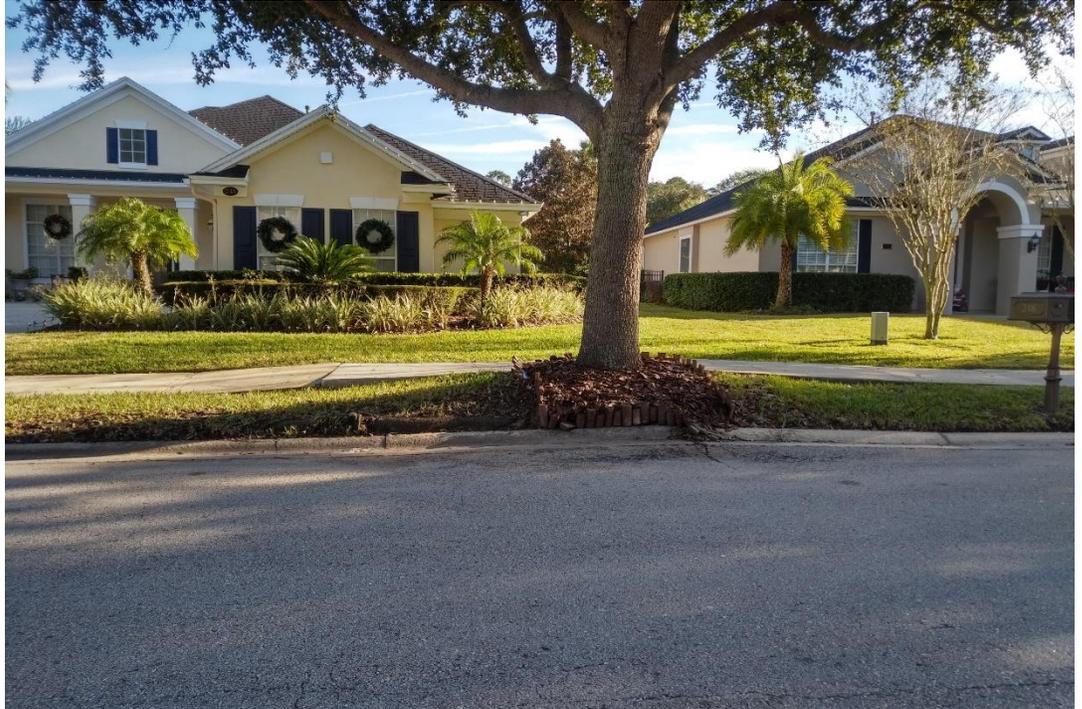
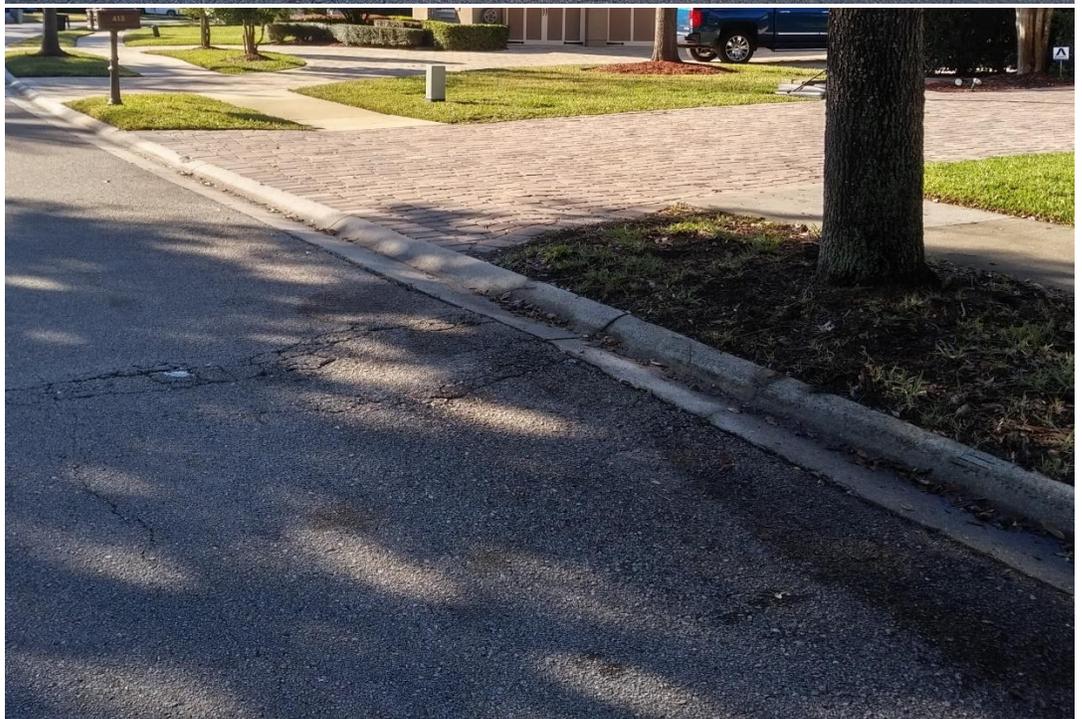
c. Street Tree Category 1,2:

1. A total of five (5) trees were observed to be significantly affecting the roadway pavement.
