Jim Oliver
Sampson Creek CDD
475 West Town Place, Suite 114
St. Augustine, FL 32092

**Re: December 18, 2018 - Roadway Maintenance Report
MDG Project No.: 16080.02**

In support of this task, this Roadway Maintenance Report summarizes the items observed during the December 18th, 2018 field investigation and provides recommendations for the CDD to consider.

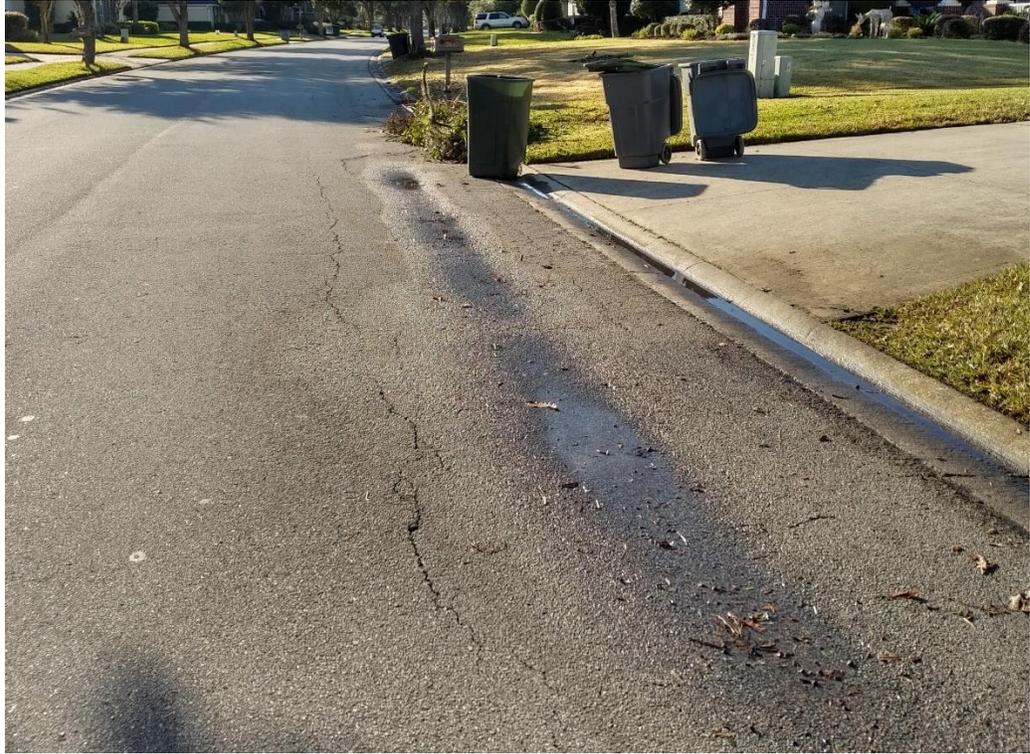
d. **Longitudinal Differential Settlement:**

1. Depressions within the travel lanes was observed to occur over approximately 400' at stations 34+00 to 38+00.
2. Recommend cores to determine best mill and resurface design.
3. Suspect the issues are due to either poor compaction of base prior to asphalt laying or high groundwater affecting the base.

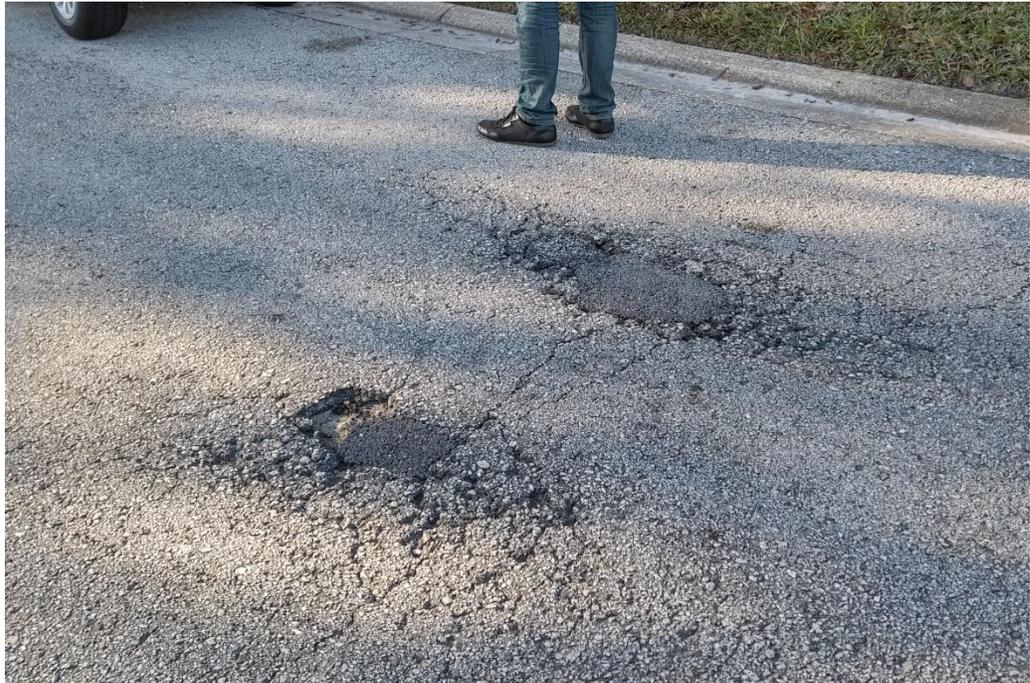
e. **Thin Asphalt Section within Pavement:**

- i.
 - 1. Multiple pavement patches were observed along St. Johns Golf Drive. These locations will require special attention when milling and resurfacing, as they will more than likely not mill evenly.

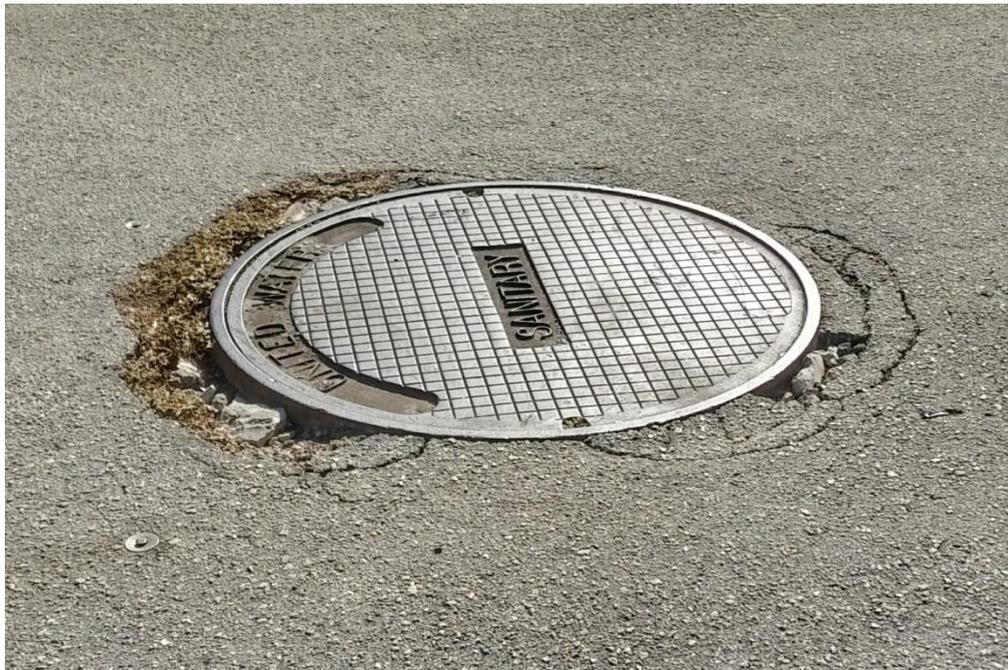
b. Sanitary Manhole:

1. Differential settlement was noted around a manhole at the intersection with Cross Pointe Way.
2. Recommend additional investigation into potential utility breaks.
3. A water meter box was observed to be completely submerged, at the ROW line immediately north of the manhole/intersection.
