Jim Oliver
Sampson Creek CDD
475 West Town Place, Suite 114
St. Augustine, FL 32092

**Re: December 18, 2018 - Roadway Maintenance Report
MDG Project No.: 16080.02**

In support of this task, this Roadway Maintenance Report summarizes the items observed during the December 18th, 2018 field investigation and provides recommendations for the CDD to consider.

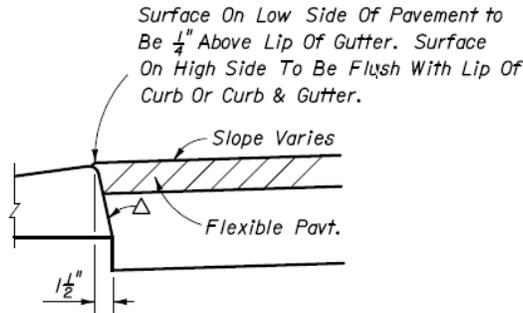
“Lip” of Pavement to Curb & Gutter Transition:

It was observed that the asphalt pavement was below the lip of the gutter for a significant portion of the subdivision’s roadways. The concern, in such a case, is that stormwater has the ability to seep between the pavement and curb face, into roadway pavement’s base course. As the stormwater within the base course now equalizes with groundwater, it can weaken the base course and further accelerate pavement deterioration.

Consideration of this should be taken when developing the roadway maintenance program. Depending on how much lower the asphalt edge is relative to the curb and gutter lip, it might be recommended to apply more asphalt than milled away. Alternatively, it might be better to reduce the amount milled if the existing asphalt thickness is found to be thin.
